Non-binding guide
to good practice
for implementing
Directive 2013/35/EU

Electromagnetic Fields

Volume 2: Case Studies

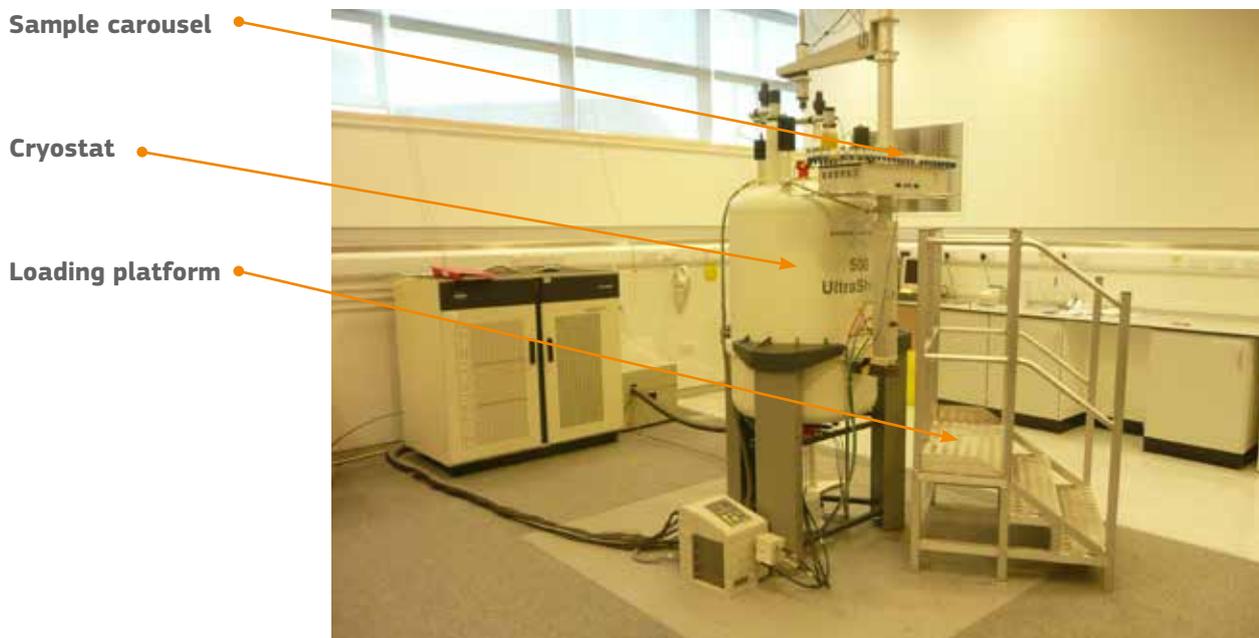
Figure 2.1 — NMR unit, complete with sample carousel and loading platform

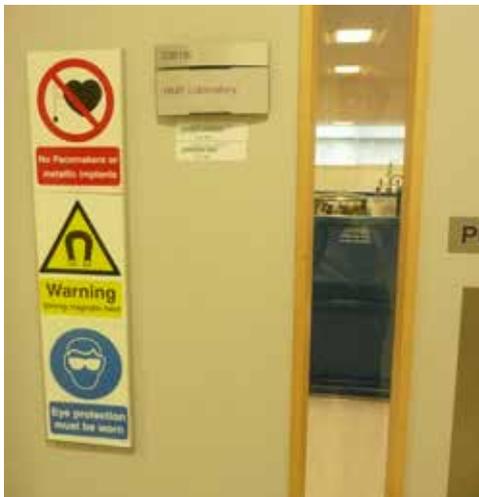
Figure 2.3 — Warning and prohibition notices on the entrance door into the NMR Laboratory

- locating the NMR units in a dedicated laboratory with physical access control, in the form of key pad access;
- posting warning and prohibition notices complying with Directive 92/58/EEC on the entrance door into the laboratory (Figure 2.3). This includes a warning for people wearing medical electronic equipment;
- preventing the entry of ferromagnetic tools and other objects into the laboratory;
- segregating the NMR units from other laboratory equipment and workstations;
- erecting a chain-link barrier and marking the floor, at the position of the 0.5 mT contour in order to control access (Figure 2.4);
- providing information, instruction and training to those working in the laboratory and ensuring that there is adequate supervision;
- requiring service engineers to provide written safety documentation and demonstrate their competence in advance of their visit.

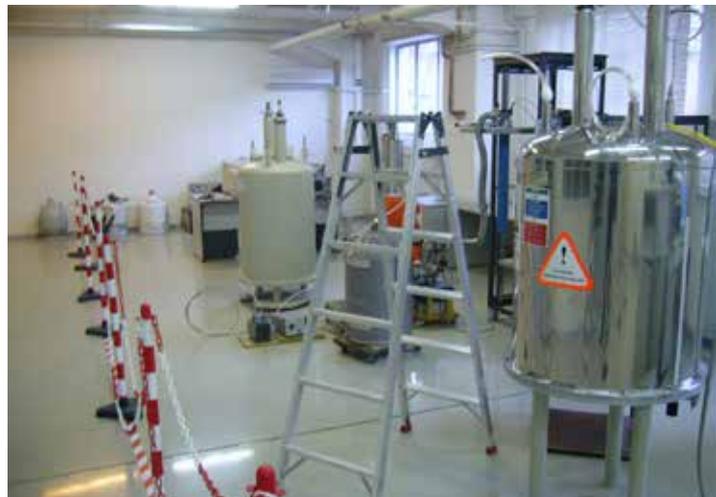
Figure 2.4 — Demarcation of the restricted area by a chain-link barrier and marking the floor

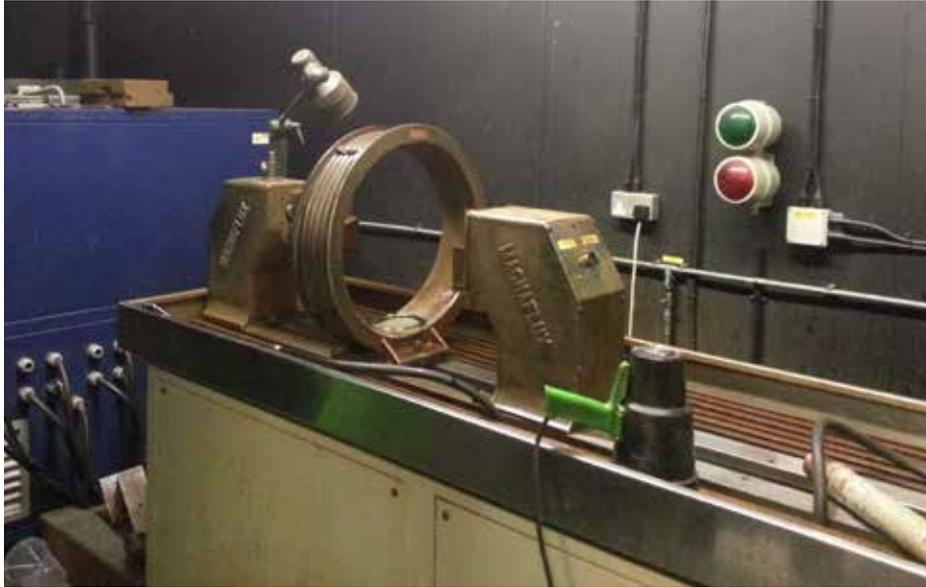
Figure 5.1 — Magnetic particle inspection unit

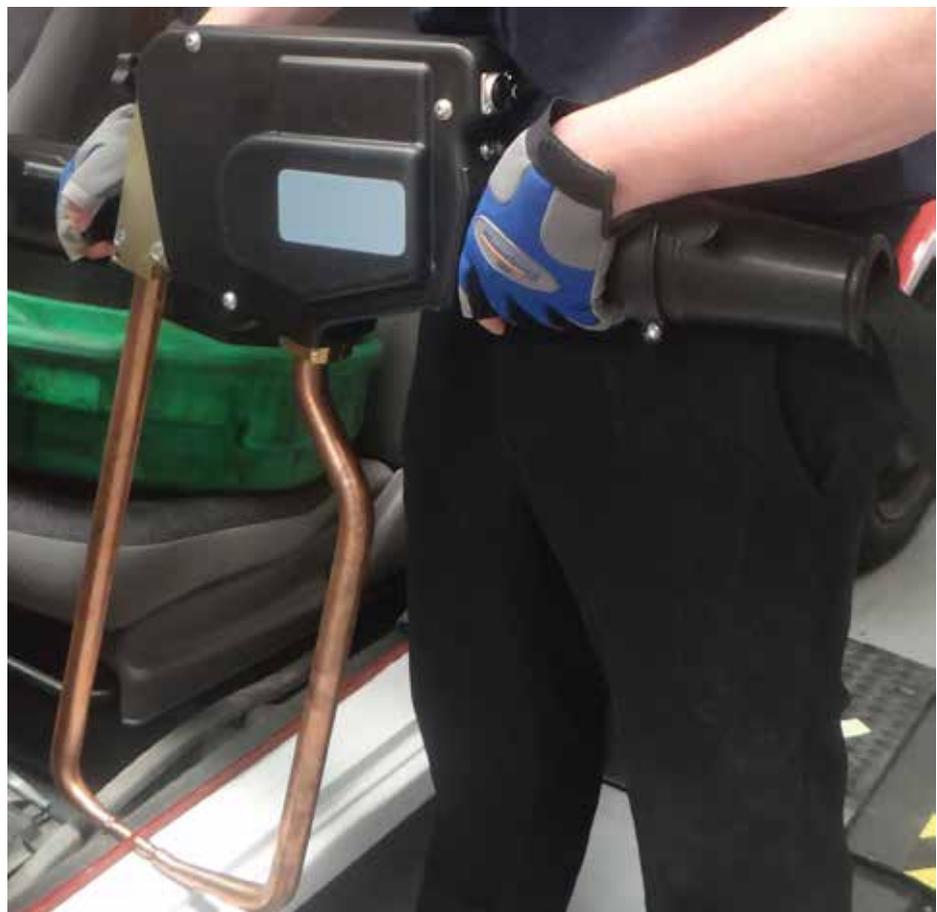
Figure 6.5 — The repair shop ‘X-type’ welding gun, with 550 mm electrodes fitted. The two electrodes are forced together in a pincer action by a piston in the main body of the gun (between the worker’s hands), which also contains the transformer supplying the welding current
